# OAK BAY ROAD CULVERT REPLACEMENTS

**Jefferson County Public Works** completed two stormwater culvert replacement projects on Oak Bay Road in April, 2011. The projects were located at Milepost (MP) 8.947 and MP 9.066 near the intersection with Scott Court. The purpose of both projects was to rehabilitate the existing culverts which were badly deteriorated and to eliminate ongoing maintenance problems. This work will reduce future maintenance costs and ensure the road's integrity.

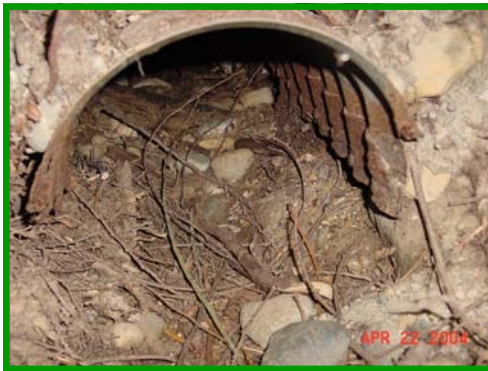
The existing cross culvert under the road at MP 8.947 was badly deteriorated.

The project at MP 8.947 constructed a new stormwater system parallel to the roadway. Stormwater was routed from the deteriorating cross culvert through new stormwater pipes to the inlet of an existing culvert adjacent to the project. The deteriorated cross culvert was then filled with grout and abandoned. The contract cost for this work was \$54,557.

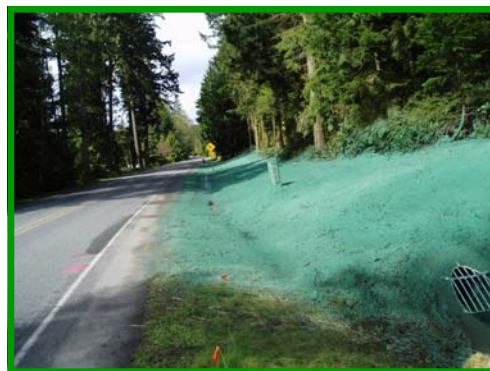
Final work included hydroseeding the construction area. The outlet of the new stormwater system is visible on the right.

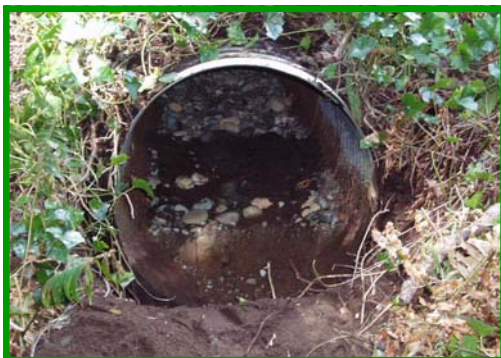
The original 36" diameter culvert under the road at MP 9.066 was badly deteriorated.

The culvert at MP 9.066 was rehabilitated using the sliplining method. Sliplining is accomplished by installing a smaller pipe inside a larger, host pipe. In this instance, 155' of 16" diameter culvert lining pipe was inserted inside the deteriorating 36" diameter pipe that crossed Oak Bay Road. The contract cost for this work was \$22,586.

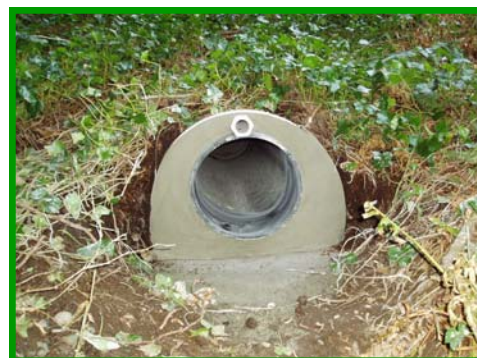
The newly installed, 'sliplined' culvert. The space between the two pipes is filled with grout and the ends sealed.
