UPPER HOH ROAD MILEPOST 4.0

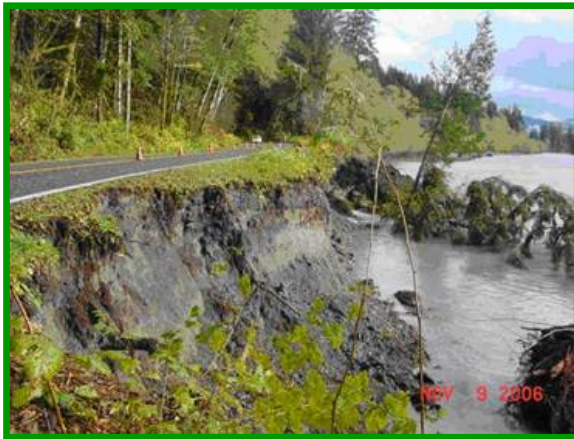
Flooding of the Hoh River washed away the river bank adjacent to the Upper Hoh Rd – in some places to within less than a foot away from the road. The river bank that remained after flooding was unstable.

Jefferson County Public Works responded immediately to the emergency to save the road. Bruch and Bruch Construction of Port Angeles was hired to construct a 400-foot long riprap revetment to protect the slope and replace the roadway embankment. Large rock was used to construct the base of the revetment. Smaller rock was placed on top of the base. The remainder of the slope extending up to roadway elevation was constructed of reinforced soil and re-vegetated with willows.

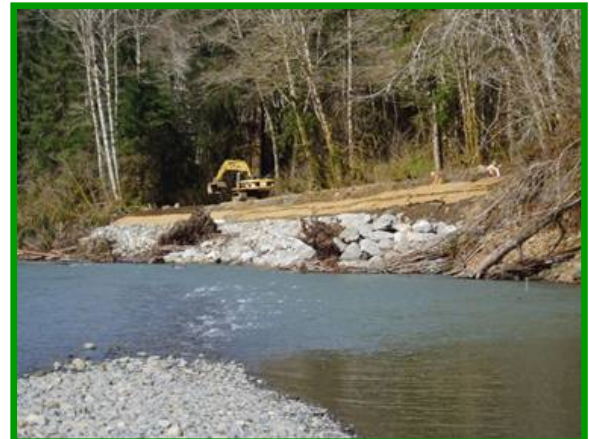
The erosion control blanket will biodegrade over time and willow roots will form a dense mat that will help to hold the embankment in place.

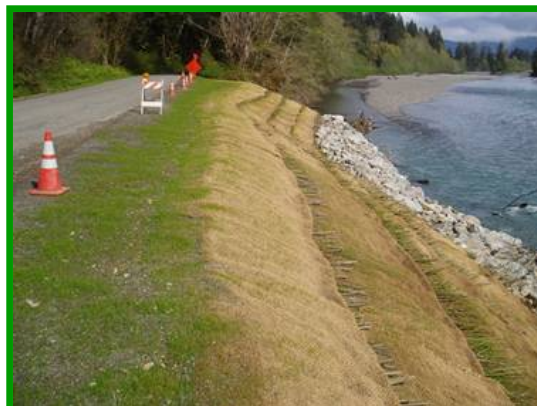
On April 17, 2007, three weeks after completion of bank reconstruction, willows and grasses began to sprout.
